T-022 Inspection Limits and Repair

Subject:	Inspection and Repair of First Stage Turbine Nozzle
EXTEX Engineered Products Part Numbers:	A23038218-738, E23038218-738, E23038218-738-P, E23038219-738, E23038219-738-P, E23038218-247, E23038218-247-P, E23038219-247, E23038219-247-P, E23062753, E23062754
Installations:	Rolls-Royce (250-B17, B17B, B17C, B17D, B17E, B17F, B17F/1, B17F/2; 250-C20, C20B, C20F, C20J, C20R, C20R/1, C20R/2, C20R/4, C20S, C20W)
Revision History:	<p>NC – Dated 1/30/97 Original Release.</p> <p>A – Dated 2/20/97 Updated format; added “FAA/DER procedure for airfoil repair”.</p> <p>B – Dated 10/30/97 Added Repair sources.</p> <p>C – Dated 05/15/98 Updated format, separated Inspect and Repair sections of manual, and Removed Repair Sources.</p> <p>D – Dated 08/12/98 Added “-P” part numbers, paragraph 2.0: Acid soak time was 10 minutes, added 90 minute maximum soak; paragraph 7.0: Added AL and Pt-Al coating options; paragraph 11.0 Added part marking requirements for coating change.</p> <p>E – Dated 07/11/00 Added MAR-M-247 nozzles.</p> <p>F – Dated 01/16/01 Added P/N’s E23062753 & E23062754.</p> <p>G – Dated 09/18/02 Table 5 revised.</p> <p>H – Dated 10/27/04 Added E23

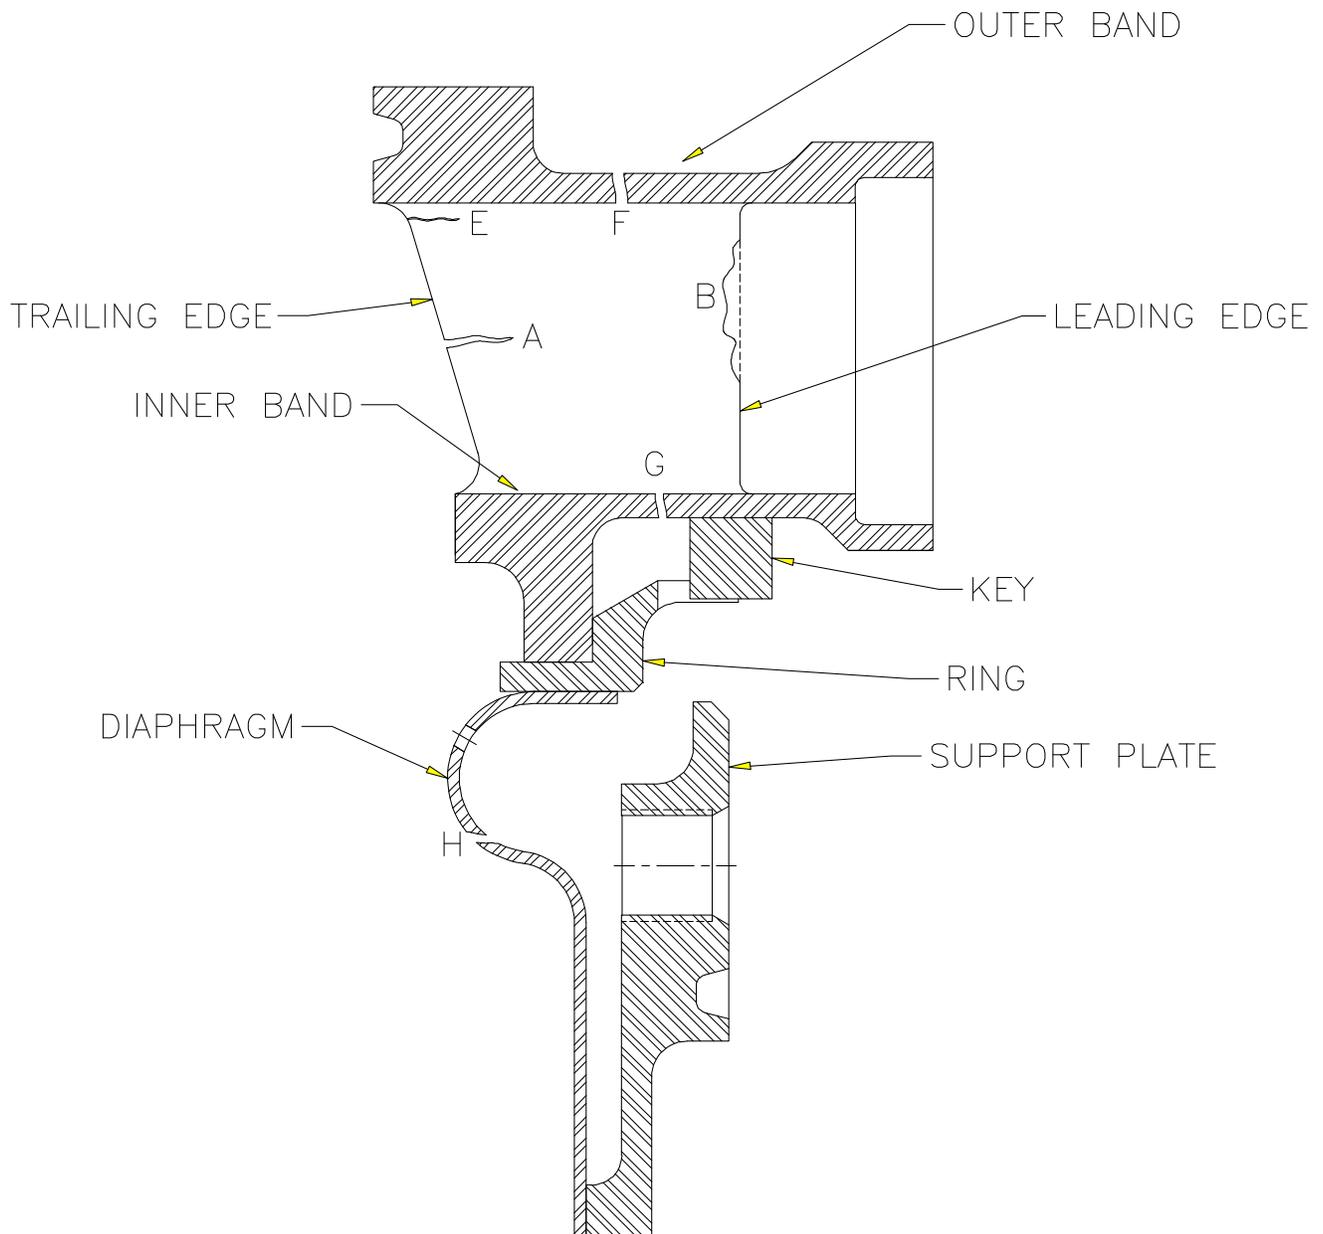
FIGURE 1

Instructions are provided for strip and recoating of gas path surfaces; weld repair of airfoil leading and trailing edges; braze repair of airfoil and fillet cracks; weld or braze repair of inner and outer band cracks, airflow adjustment; and replacement of diaphragm and support plate. Figure 1 depicts key features of the subject nozzles.

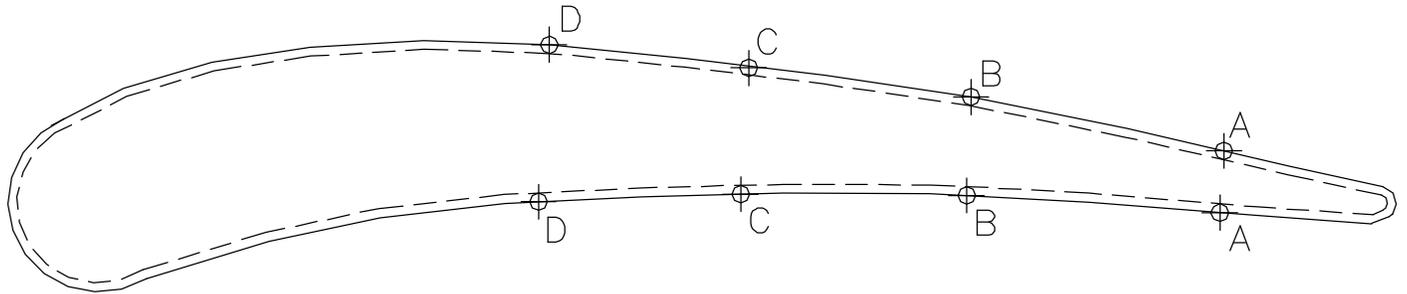
FIGURE 5

Location	Distance from Trailing Edge [inches (mm)] – Measured along airfoil surface	Airfoil Minimum Thickness [inches (mm)] – Thickness in fillet radius not measured
A	0.125 (3.17)	0.019 (0.53)
B	0.250 (6.35)	0.031 (0.86)
C	0.375 (9.52)	0.047 (1.19)
D	0.500 (12.70)	0.062 (1.70)

EFA of repaired nozzles must be checked and modified if not within acceptable range. See Sections 6 or 10. Repaired airfoils must meet minimum dimensions shown in Figure 5.
