T-029 Inspection Limits and Repair

1st Stage Turbine Nozzle Assembly

E23008064, E23008064-738 & E23062028-738
First Stage Turbine Nozzle Assembly
Inspection and Rework Limit

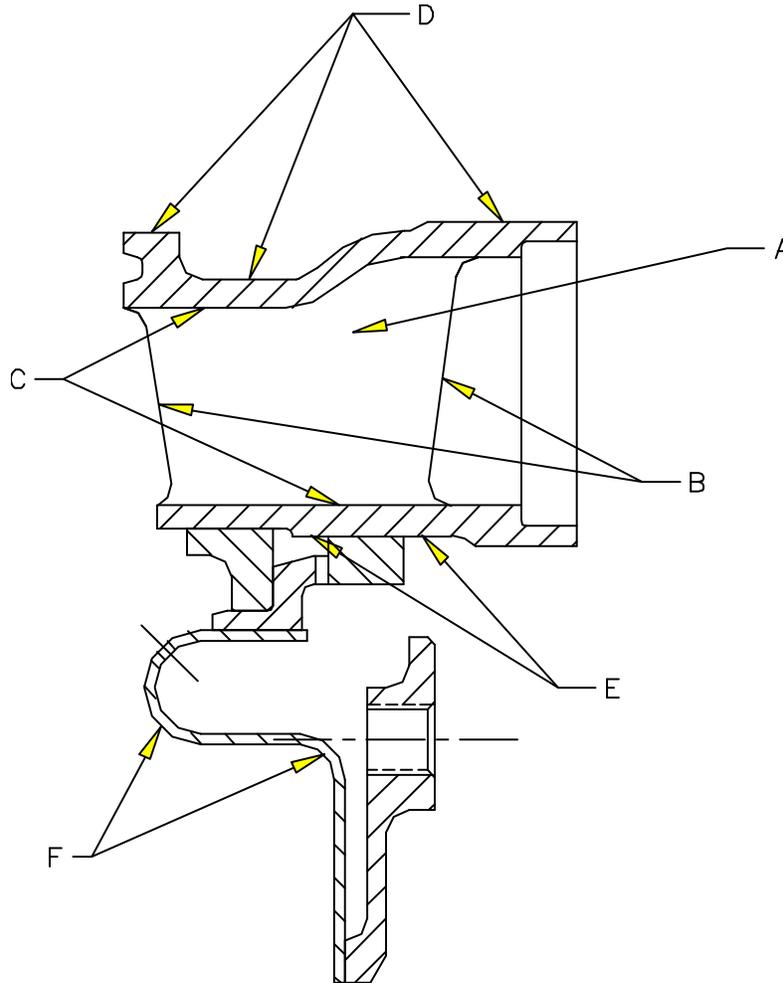
FIGURE 1

Code Letter	Location	Description of Condition
A	Vane Airfoil	Cracks
B	Vane Leading Edge Vane Trailing Edge	Nicked, Dented Nicked, Dented, Warped, Burned
C	Vane Fillet	Cracks
D	Outer Band	Cracks
E	Inner Band	Cracks
F	Diaphragm	Cracks

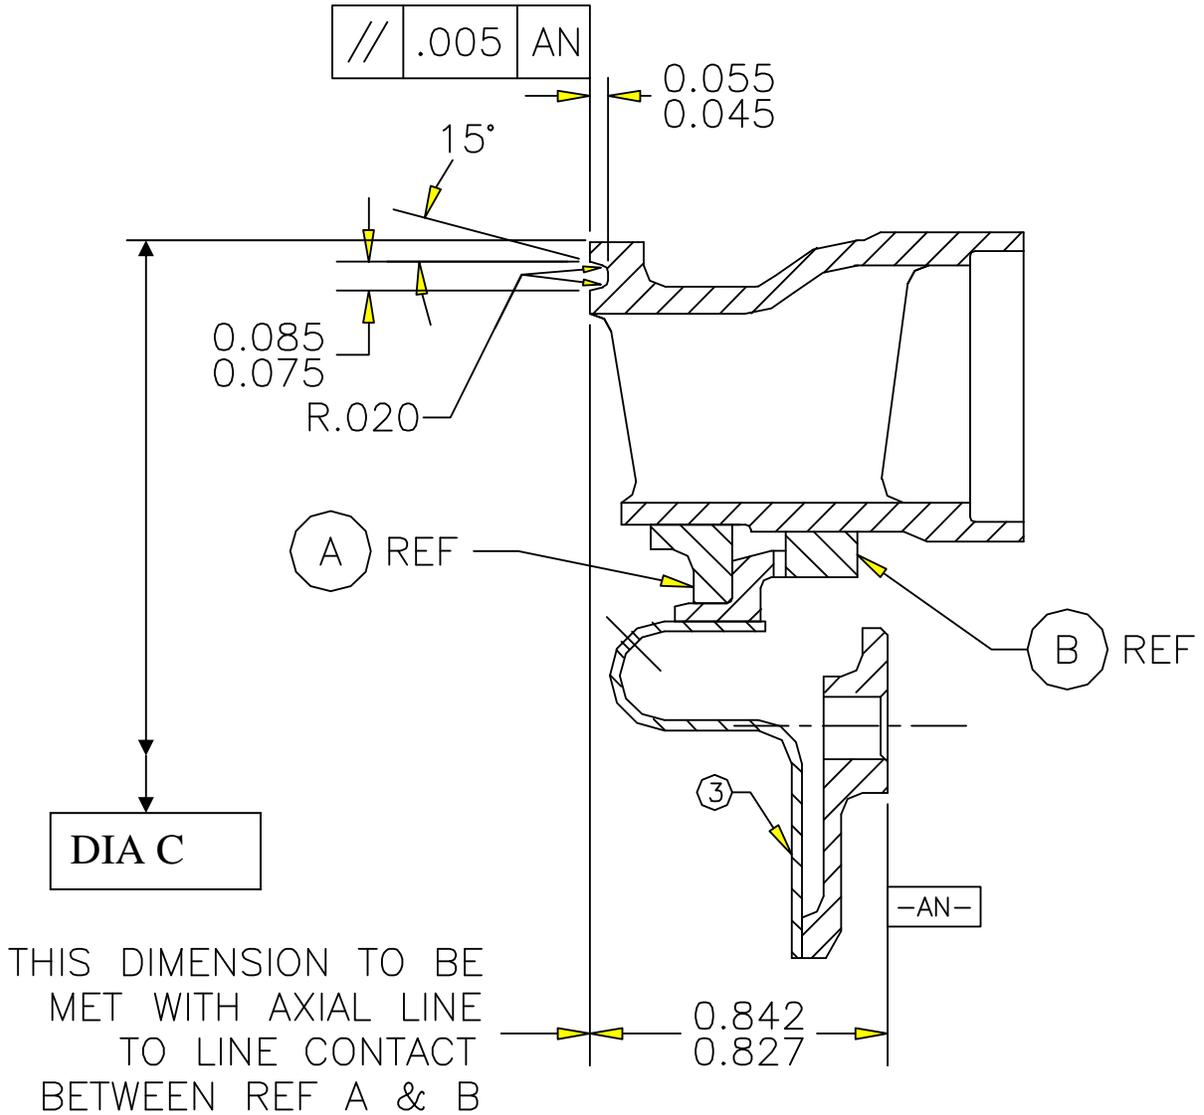
FIGURE 2

THIS DIMENSION TO BE MET WITH AXIAL LINE TO LINE CONTACT BETWEEN REF A & B

FOR DIMENSIONAL RESTORATION OF PACKING GROOVE, METALLIZE USING METCO 450. DIMENSIONS ARE IN INCHES.

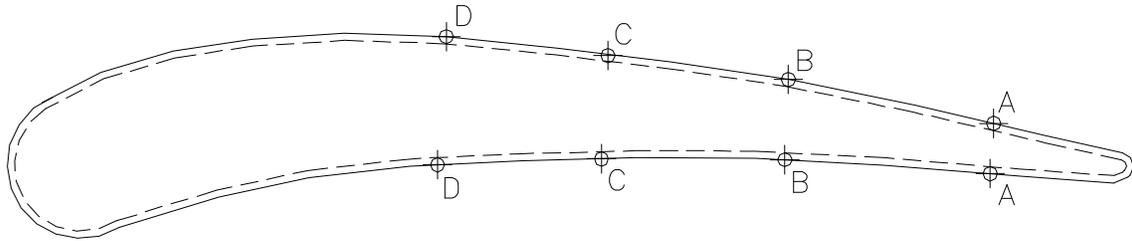
FIGURE 3 (sheet 1 of 2)

Location	Distance from Trailing Edge inch	Airfoil Minimum Thickness inch
A	0.125	0.038
B	0.250	0.053
C	0.375	0.072
D	0.500	0.094

- * Distance measured along airfoil surface.
- ** Do not measure thickness in fillet radius.
