T-045 Inspection Limits and Repair

Subject:	Installation Procedure for the E6888547-UC Power Turbine Support Oil Sump Cover Assembly.
EEP Part Numbers:	E6888547-UC
Installations:	Rolls-Royce (250-B17, B17B, B17C, B17D, B17E; C18, C18A, C18B, C18C; C20, C20B, C20F, C20J, C20R, C20R/1, C20R/2, C20R/4, C20S, C20W)
Revision History:	N/C Dated: 06/22/98 Original Issue. A Dated: 09/03/09 Updated EXTEX to TIMKEN. B Dated: 10/30/13 Added instructions to update the part marking revision letter. Updated format. C Dated: 2/04/16 Updated Timken to EXTEX Engineered Products.
Reason:	To provide Supplemental Instruction for Continued Airworthiness (ICA)
Description:	The E6888547-UC Oil Sump Cover Assemblies are manufactured with .015" machining stock remaining on the abradable seal diameters. This allows the overhaul facility to custom machine the cover for specific labyrinth seals to optimize performance. Refer to Type Certificate Holder's published data for installation, engine operation, and disassembly.

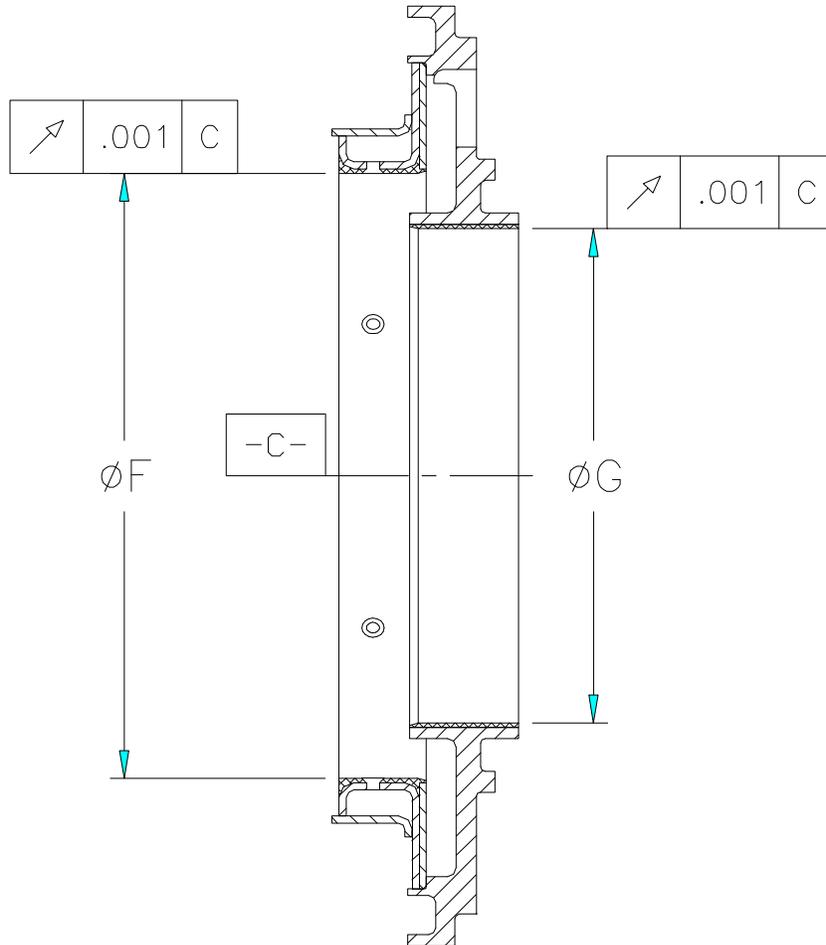
FIGURE 1

Accomplishment: Before installation of the Power Turbine Support Oil Sump Cover Assembly, machine the seal surfaces to allow the desired rotating lab seal clearances. Cover Assy is shown in Figure 1. Dimensions of seal surfaces are not to exceed the following:

Largest Allowable Dimensions	
Diameter F	Diameter G
2.724	2.226
