T-067 Inspection Limits and Repair

2nd Stage Turbine Nozzle Floating Diaphragm Assembly

Engine Application(s): 250-C20B, C20F, C20J, C20C, C20R, C20R/1, C20R/2, C20R/4

Subject: Installation, Inspection and Rework Procedures for the E23072654 & E23072654-UC 2nd Stage Turbine Nozzle Floating Diaphragm Assembly.

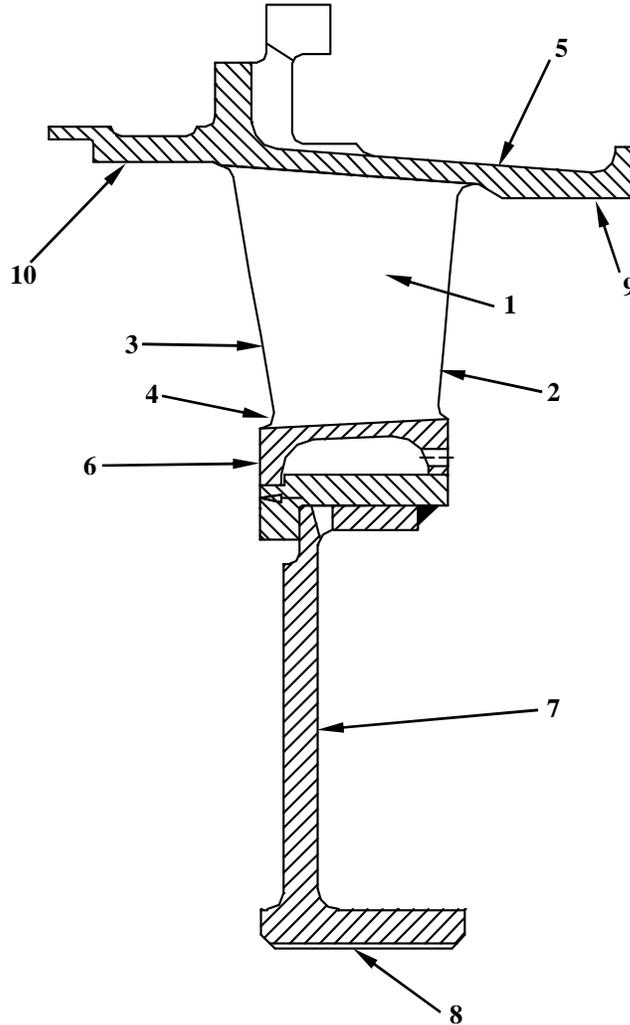
FIGURE 1

Key	Location	Description of Condition
1	Vane Airfoil	Cracks
2	Vane Leading Edge	Nicked, Dented
3	Vane Trailing Edge	Nicked, Dented, Warped, Burned
4	Vane Fillet	Cracks
5	Outer Band	Cracks
6	Inner Band	Cracks
7	Diaphragm	Cracks
8	Seal Surface	Wear
9	#1 Blade Tip Path	Wear
10	#2 Blade Tip Path	Wear or Warped
