T-103 Alert Service Bulletin

Subject:	Possible obstruction of nozzle cooling passages
Part Number(s):	E23031938 23031938 (Overhauled in accordance with FAA approved major repair # ART-1033)
Installation(s):	Rolls Royce 250-B17F, B17F/1, B17F/2, C20, C20B, C20C, C20F, C20J, C20S, C20W, C20R, C20R/1, C20R/2, C20R/4
Revision History:	Rev. IR: Initial Release Rev A: Removed serial number 100739 from affected serial number list. Rev B: Updated Timken to EXTEX Engineered Products.
NOTE: On 10-20-15, Timken Alcor Aerospace Technologies, Inc. (TAATI) was acquired by Kaman Corporation and renamed EXTEX Engineered Products, Inc.	
Reason:	Timken Alcor Aerospace Technologies, Inc. (TAATI) has identified a specific number of 2 nd stage turbine nozzle assemblies that may have residual casting ceramic core material obstructing (either partially or fully) the cast-in cooling passages. EEP design data permits a maximum of two (2) fully blocked passages. A 2 nd stage nozzle with more than two (2) obstructed passages may restrict the cooling air flow to the 1 st and 2 nd stage turbine wheels that could result in reduced operational life and/or possible premature turbine disk failure.

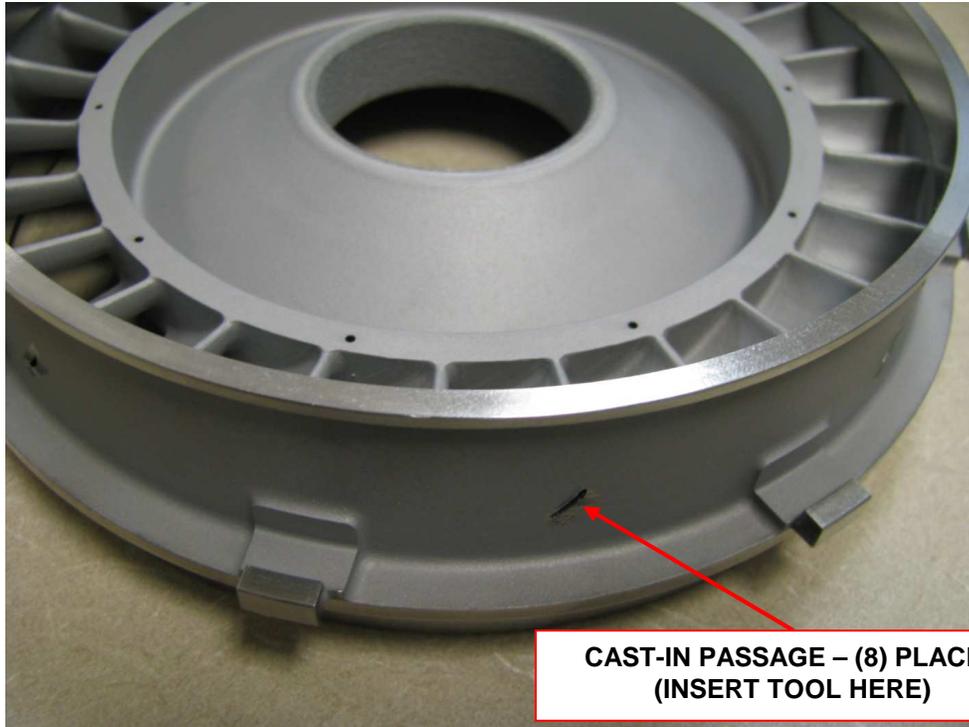
FIGURE 1
(2ND STAGE NOZZLE ASSY)

At the earlier of 120 operating hours or 6 months from issue date of this ASB, access the 2nd stage turbine nozzle such that the eight (8) cooling passages are visible and accessible (see figure 1). For proper disassembly of the turbine module to access the 2nd stage nozzle, refer to Rolls Royce C20 Series, Operation & Maintenance Manual, Publication No. 10W2, Section 72-50-00, "Turbine Section – Maintenance Practices".

Inspect each passage (ref. figure 1) using either a TAATI supplied tool or locally fabricated tool constructed from .005" shim stock. The recommended design is described in figure 2.

- **The tool can be fully inserted through 6 or more passages:**
No further action is required as the nozzle has two (2) or fewer obstructed passages.
- **The tool can be fully inserted through 5 or fewer passages:**
 1. Remove 2nd stage nozzle assembly along with 1st and 2nd stage turbine wheels.
 2. Contact TAATI representative to obtain Return Material Authorization (RMA) number.
 3. TAATI will inspect the 2nd stage nozzle to confirm the condition of the passages.
 4. If the nozzle is confirmed to have 3 or more obstructed passages, the 1st and 2nd stage turbine wheels are no longer serviceable and must not be re-installed.

TAATI will remove the nozzle diaphragm, remove any material from the obstructed passages and repair in accordance with Extex Overhaul Services (TOS) FAA Approved major repair # ART-1033.

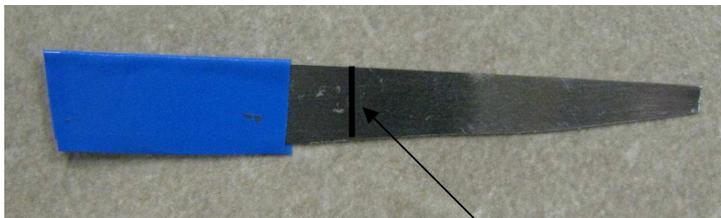
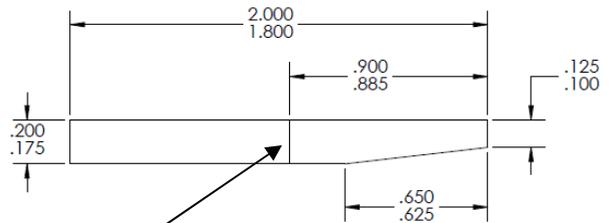
FIGURE 2
(INSPECTION TOOL - .005" THICK SHIM STOCK)

Insert the tool in each of the eight (8) cooling passages. In an open passage, the tool can be inserted without restriction until it contacts the sheet metal diaphragm at the nozzle I.D. The tool should be marked with a line signifying that it has been inserted to the proper depth (ref. figure 2). In addition to the marking, you can also determine that the tool is fully inserted by the sound and feel of the tool contacting the sheet metal detail.
