T-401 Inspection Limits and Repair

**E3840004-5 1st Stage Turbine Blade
E3840008-2 2nd Stage Turbine Blade**

Engine Application(s):	Allied Signal 331-200 and -250 Series Auxiliary Power Unit.	
Subject:	Inspection Limits and Repair	
Compliance:	On condition.	
Revisions:	N/C	Dated 10/8/99 Original issue.
	A	Dated 7/23/09 Updated EXTEX to TIMKEN.
	B	Dated 2/08/16 Updated Timken to EXTEX Engineered Products.

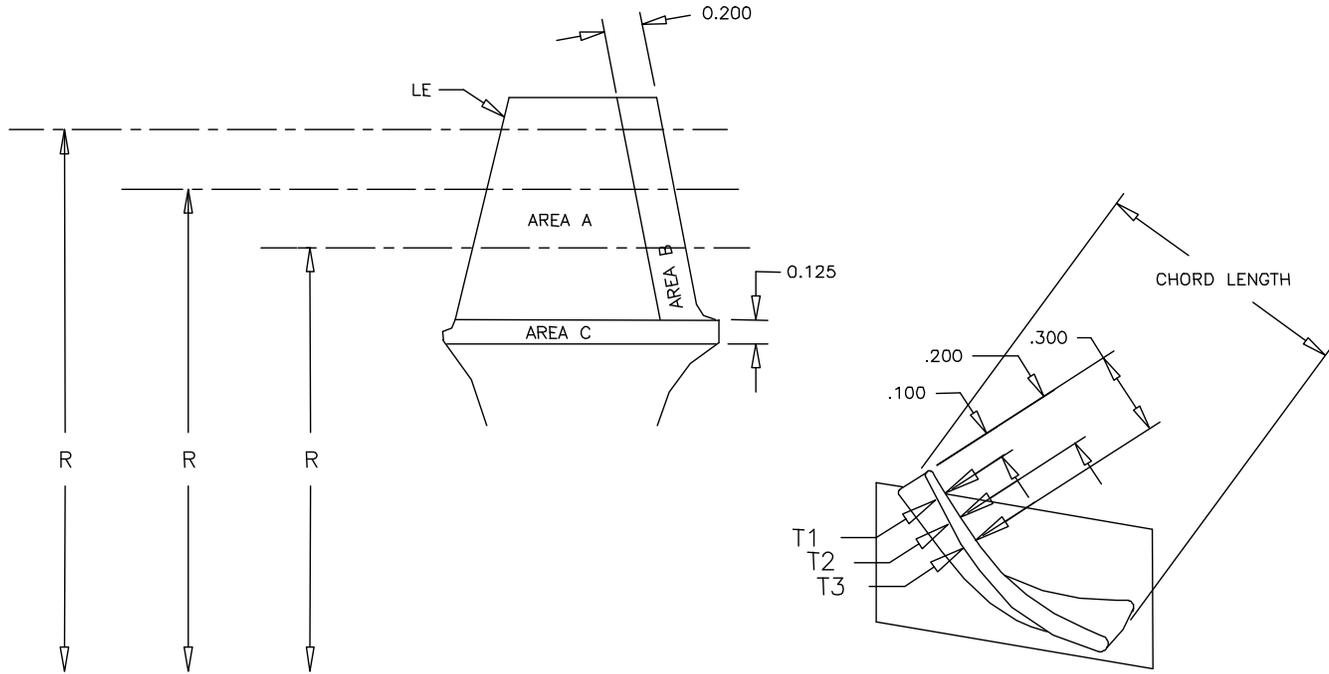
E3840004-5				
FIRST STAGE BLADE – MINIMUM LIMITS				
RADIUS	T1	T2	T3	CHORD LENGTH
R=3.163	0.0204	0.0348	0.0597	0.906
R=3.363	0.0177	0.0225	0.0382	0.882
R=3.500	0.0165	0.0178	0.0244	0.876

E3840008-2				
SECOND STAGE BLADE – MINIMUM LIMITS				
RADIUS	T1	T2	T3	CHORD LENGTH
R=2.963	0.0216	0.0344	0.0594	0.959
R=3.163	0.0208	0.0321	0.0531	0.942
R=3.263	0.0203	0.0301	0.0484	0.943
R=3.562	0.0192	0.0255	0.0363	0.963
R=3.863	0.0183	0.0199	0.0256	0.984

- LE Radius may be blended provided part meets all dimensional requirements in Figure 1 after blending. Full radius must be re-established on leading edge after blending.
- TE erosion thinning is acceptable provided the airfoil meets all limits in Figure 1.
- After erosion repair, strip, heat tint, FPI, clean and re-coat as above.
