T-402 Inspection Limits and Repair

**E3826099 Inlet Guide Vane
EN3826099 Inlet Guide Vane, Nickel**

Engine Application(s):	Allied Signal 331-200 and -250 Series Auxiliary Power Unit.	
Subject:	Inspection and Repair Limits	
Compliance:	On condition.	
Revisions:	N/C A B	Dated 11/8/99 Original issue. Dated 8/04/09 Updated EXTEX to TIMKEN. Dated 2/08/16 Updated Timken to EXTEX Engineered Products.

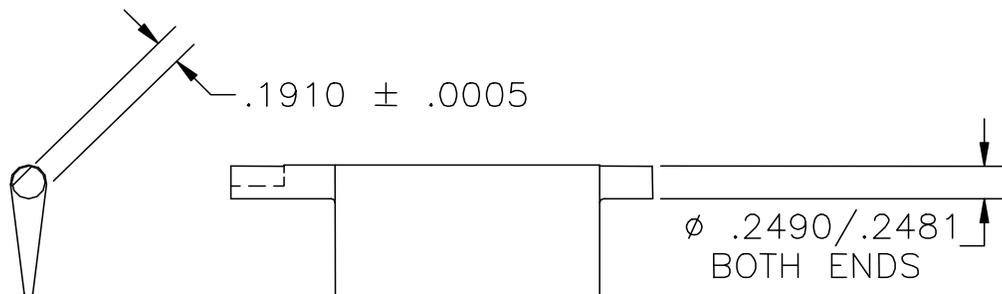
3.0 Dimensional Repaired Limits

Note: Plating thickness to be .0007" minimum, .0025" maximum

Feature	Service Limit	Repair Limit	Corrective Action
Coating integrity E3826099 only	Wear or corrosion through the hard anodize is not permitted.	None.	Replace
Plating integrity EN3826099 only	Wear or locally missing areas of plating are not to be re-installed.	Worn or locally missing areas of plating may be repaired provided base material of vane is not compromised.	Strip nickel plate and re-plate per AMS 2405. Repaired dimensions in Figure 1 must be maintained after plating.
Vane stem and sector gear flats	Nicks or gouges are not permitted.	None	Replace
All other areas of vane – airfoil, machined slots	Nicks or gouges up to .005 deep may be returned to service after dressing any positive material to flush.	Nicks or gouges up to .015 deep may be blended after stripping of nickel plate.	Re-plate per AMS 2405. Repaired dimensions in Figure 1 must be maintained after plating.
