**T-009 Inspection Limits and Repair**

<b>Subject:</b>	Inspection and Repair of Second Stage Turbine Nozzles
<b>EXTEX Part Numbers:</b>	A23031938, E23031938, A23031938-C, E23031938-C, 23031938AL, E6878426, E6878426-C
<b>Installations:</b>	Rolls-Royce (250-B17, B17B, B17C, B17D, B17E, B17F, B17F/1, B17F/2; 250-C18, C18A, C18B, C18C; 250-C20, C20B, C20C, C20F, C20J, C20R, C20R/1, C20R/2, C20R/4, C20S, C20W)
<b>Revision History:</b>	<p>NC – Dated 1/30/97 Original Issue.</p> <p>A – Dated 2/20/97 Updated format; added “FAA/DER procedure for airfoil repair”.</p> <p>B – Dated 11/28/97 Added Repair sources.</p> <p>C – Dated 6/08/98 Updated format, separated Inspect and Repair sections of manual, and removed Repair sources.</p> <p>D – Dated 3/16/99 Added Note 3 on page 2; changed compliance.</p> <p>E – Dated 6/26/03 Added min wall thickness on page 8. Incorporated tang weld repair to Note 4 on page 8. Added Metco 444 to PAR 5.0. Added AMS 2675 to PAR 6.0. Added braze spec and alloy spec to PAR 9.0. Added Repair Procedure 12 on page 10.</p> <p>F – Dated 3/16/05 Added E – Vane Fillet Cracks service limits and corrective actions.</p> <p>G – Dated 5/24/07 In Section 4.0, “see Section 6” was “s

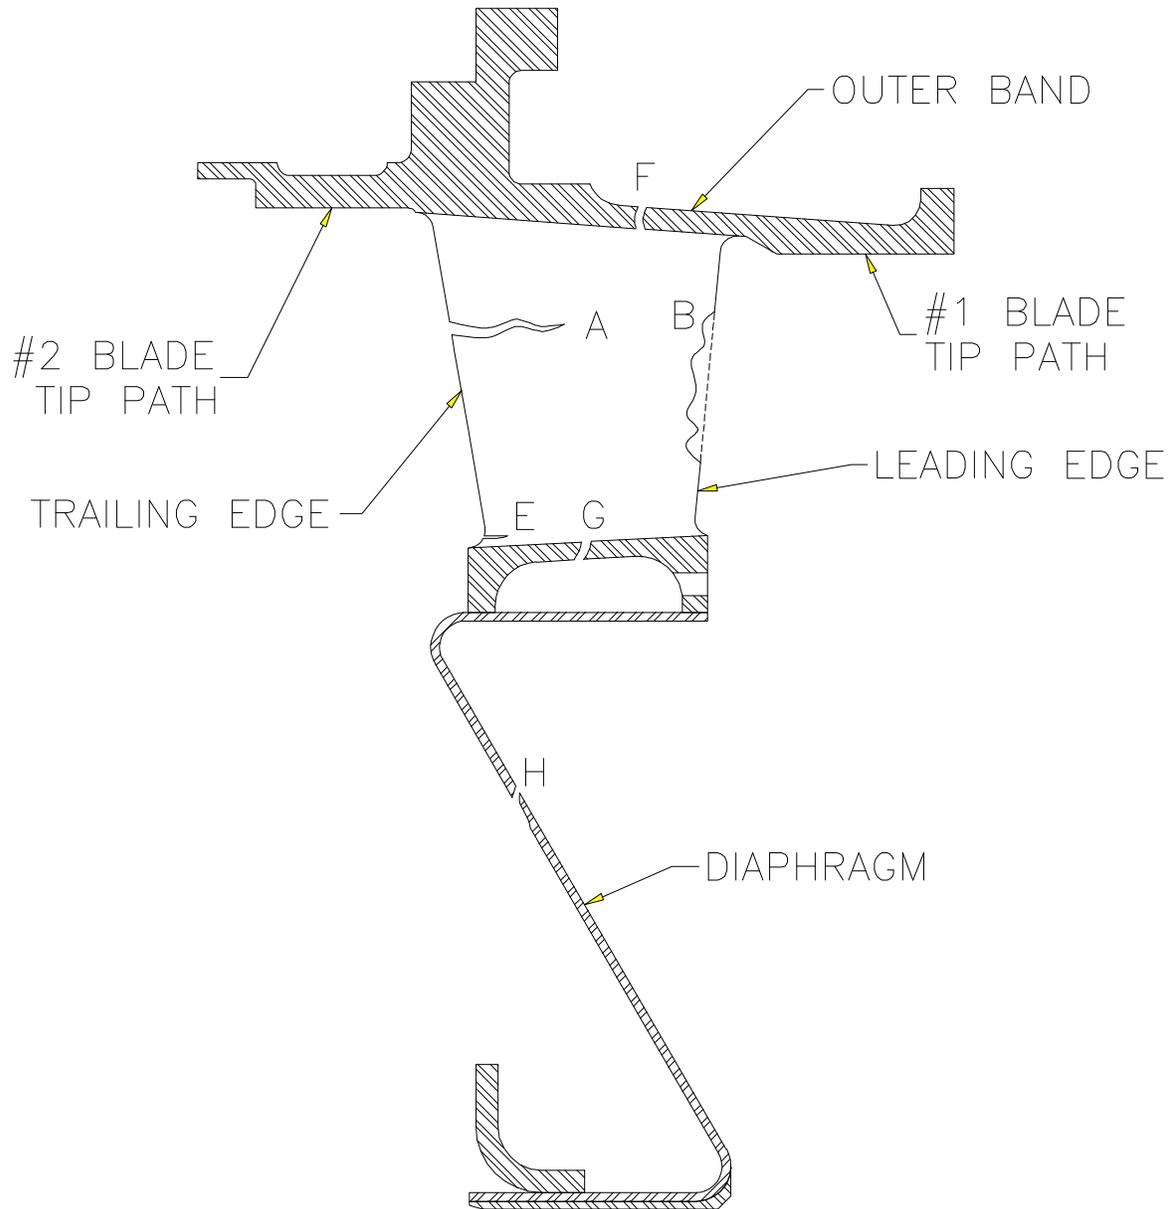
**FIGURE 1**

Instructions are provided to strip coating from gas path surfaces; weld repair of airfoil leading and trailing edges; braze repair of airfoil and fillet cracks; weld or braze repair of inner and outer band cracks, airflow adjustment; and replacement of diaphragm and support plate. Figure 1 depicts key features of the subject nozzles.

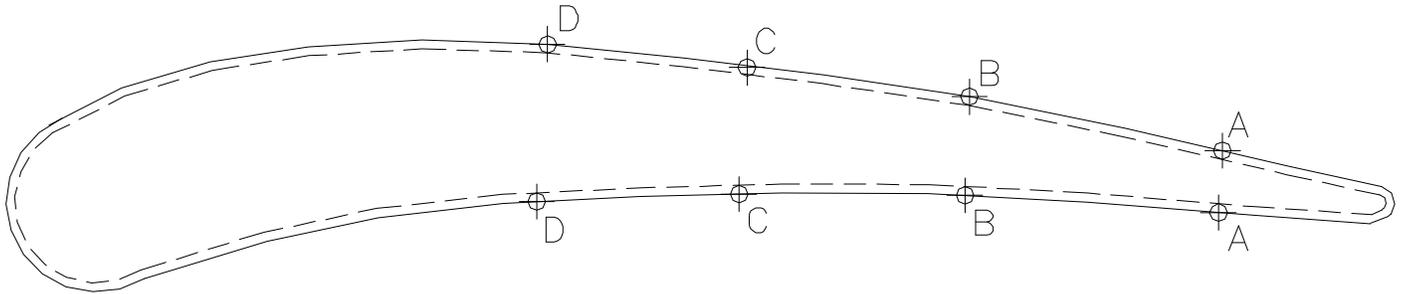
**FIGURE 4**

Location	Distance from Trailing Edge [inches (mm)] - Measured along airfoil surface	Airfoil Minimum Thickness [inches (mm)] - Thickness in fillet radius not measured
A	0.125 (3.17)	0.022 (0.56)
B	0.250 (6.35)	0.034 (0.86)
C	0.375 (9.52)	0.048 (1.22)
D	0.500 (12.70)	0.068 (1.73)

EFA of repaired nozzles must be checked and modified if not within acceptable range. See Section 10. Repaired airfoils must meet minimum dimensions shown in Figure 4.
