T-301 Inspection Limits and Repair

E3611904-1 Turbine Shroud

Engine Application(s):	Allied Signal 85 Series Auxiliary Power Unit.	
Subject:	Inspection and Repair Limits	
Compliance:	On condition.	
Revisions:	N/C A B	Dated 9/27/99 Original issue. Dated 8/04/09 Updated from EXTEX to TIMKEN. Dated 2/08/16 Updated from Timken to EXTEX Engineered Products.

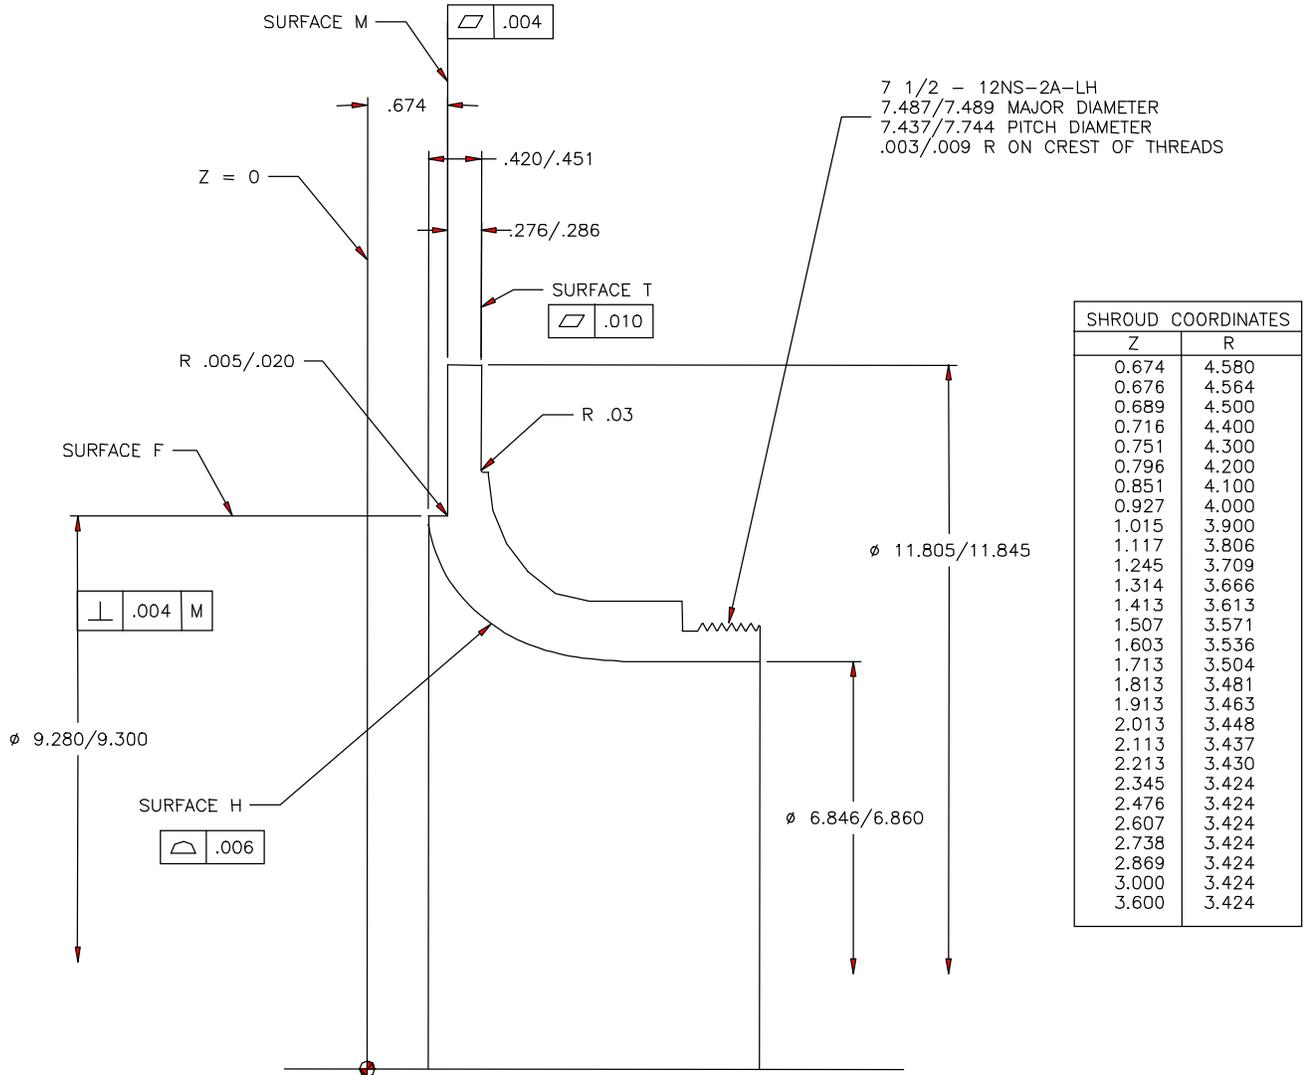
FIGURE 1

Feature	Service Limit	Repair Limit	Corrective Action
Surface M	Cracks which do not extend below the bolt hole are acceptable.	Cracks which extend beyond bolt hole or are progressing toward one another are not acceptable.	Replace
Surface M	Fretting by spacers not more than .015 deep on three locations.	Flange thickness must be .250 minimum after clean-up.	Machine per Figure 1.
Surface T	Cracks which do not extend below the bolt hole are acceptable.		Replace
Surface H	Rub marks up to .030" deep are acceptable.	Positives such as ridges or metal build-up are not acceptable.	Blend as necessary to remove positives.
Threads	7.487- 7.489" Diameter 7 1/2 - 12NS-2A-LH threads 7.437 - 7.444" Pitch Diameter .003 - .009 " radius on crest	Inspect for worn, crossed, stripped, peened, burred, nicked or dented threads.	Chase threads per Figure 1.

E3611904-1 TURBINE SHROUD
REPAIRED LIMITS

- All parts returned to service must meet the dimensions in Figure 1.
- A minimum amount of material is to be removed if machining is necessary to comply with any of the dimensions.
- For feature control limits on surfaces which have been distorted, 90% compliance of the surface to the feature tolerance is required.
- 9.280/9.300 diameter may be dimensionally restored using Metco 450 or equivalent metal spray, applied per manufacturer's instructions.
