## T-601 Inspection Limits and Repair

### 3840223-4E, E3840282-3 1<sup>st</sup> Stage Turbine Blades

<b>Engine Application(s):</b>	Honeywell (Allied Signal) 131-9 Series Auxiliary Power Unit (APU).	
<b>Subject:</b>	Inspection and Repair Limits	
<b>Compliance:</b>	On condition or at scheduled APU service event.	
<b>Revisions:</b>	A	Dated: 1/29/07
	B	Dated: 7/20/09 Added E3840282-3. Updated from EXTEX to TIMKEN.
	C	Dated: 2/08/16 Updated from Timken to EXTEX Engineered Products.

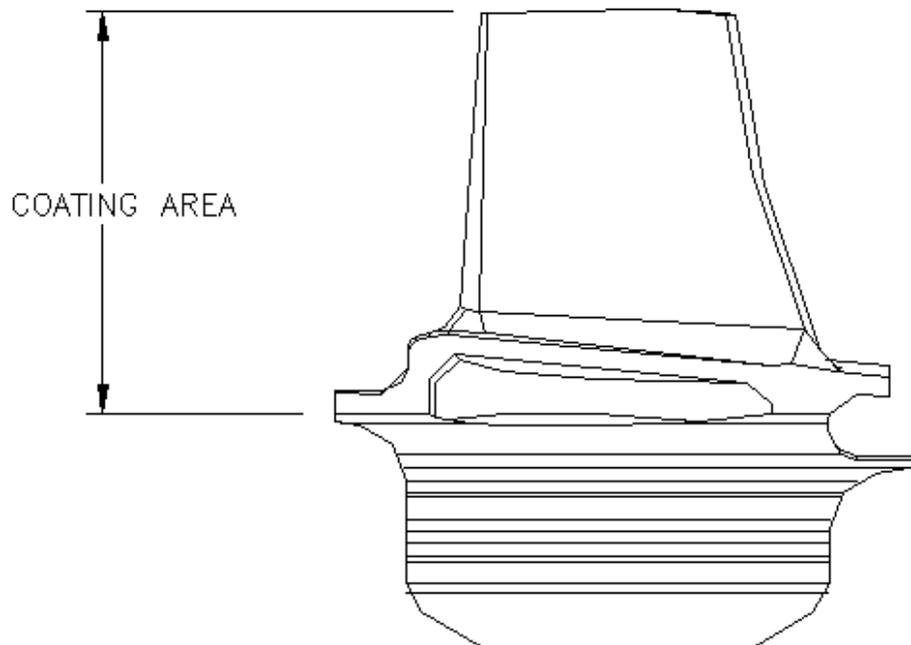
### Figure 1 – Coating Definition

- 3840223-4E blades coated with diffused platinum aluminide were manufactured without metal spray on the fir tree and are marked with a lot number of 50091 or higher. All E3840282-3 blades have the diffused platinum aluminide coating and were manufactured without metal spray on the fir tree.
- The airfoil is coated with a diffused Pt-Al coating and the under platform "pocket" is coated with a simple diffused aluminide (reference Figure 1) for improved corrosion resistance.
- Inspect the blade fir tree for wear per Figure 2.
- Inspect the airfoil for serviceability per Figure 3.
- After coating, shot peen the fir tree per Figure 4.

**Coating Area:** Coat platform and airfoil where shown with diffused platinum aluminide. Optional to coat ground sides of platform. Coat underneath platform with diffused aluminide. Leakage past the masking permitted provided the firtree lobe is not coated. After coating, age at 1600 deg. F +/- 25 deg. F for 20 hours +/- 15 minutes and air cool.

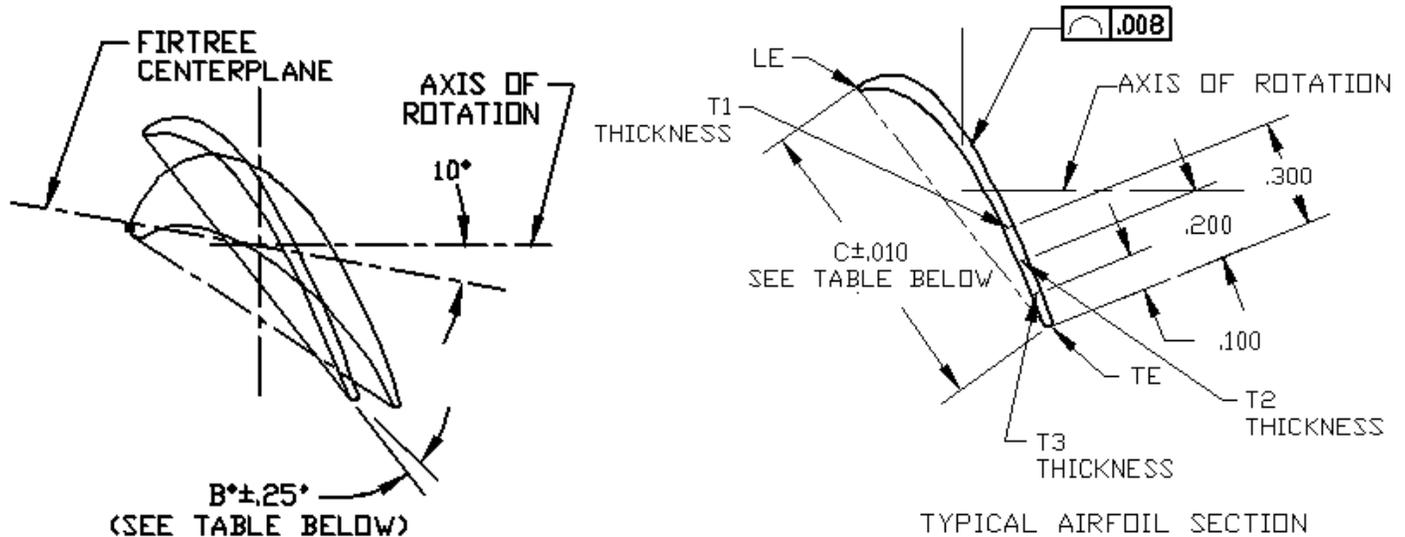
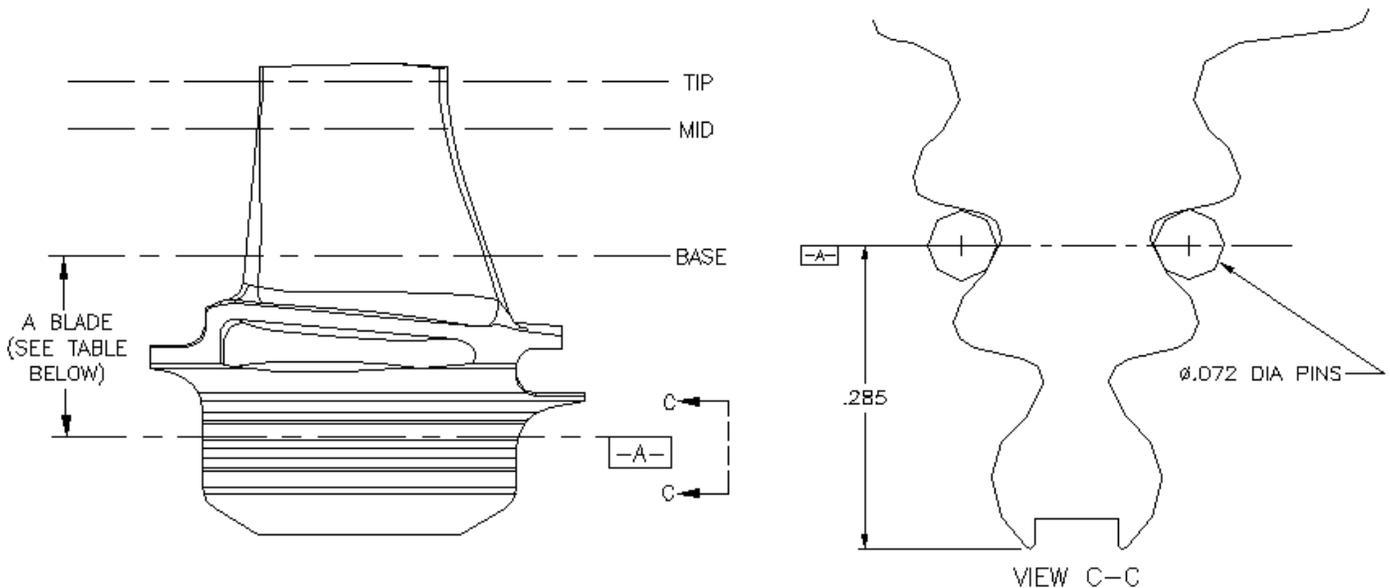
**Figure 3 - Airfoil Inspection**

**First Stage Turbine Blade Airfoil Dimensions**

A	B ANGLE	C	SECTION	T1	T2	T3
0.575	0.00	0.820	BASE	0.070 MIN	0.043 MIN	0.027 MIN
0.775	10.44	0.823	MID	0.040 MIN	0.028 MIN	0.023 MIN
0.975	18.78	0.856	TIP	0.023 MIN	0.022 MIN	0.028 MIN
